Recycled Water Reuse Program
Idaho Department of Environmental Quality
Twin Falls Regional Office

City of Bellevue

Municipal Permit M-112-03

2025 Inspection Report

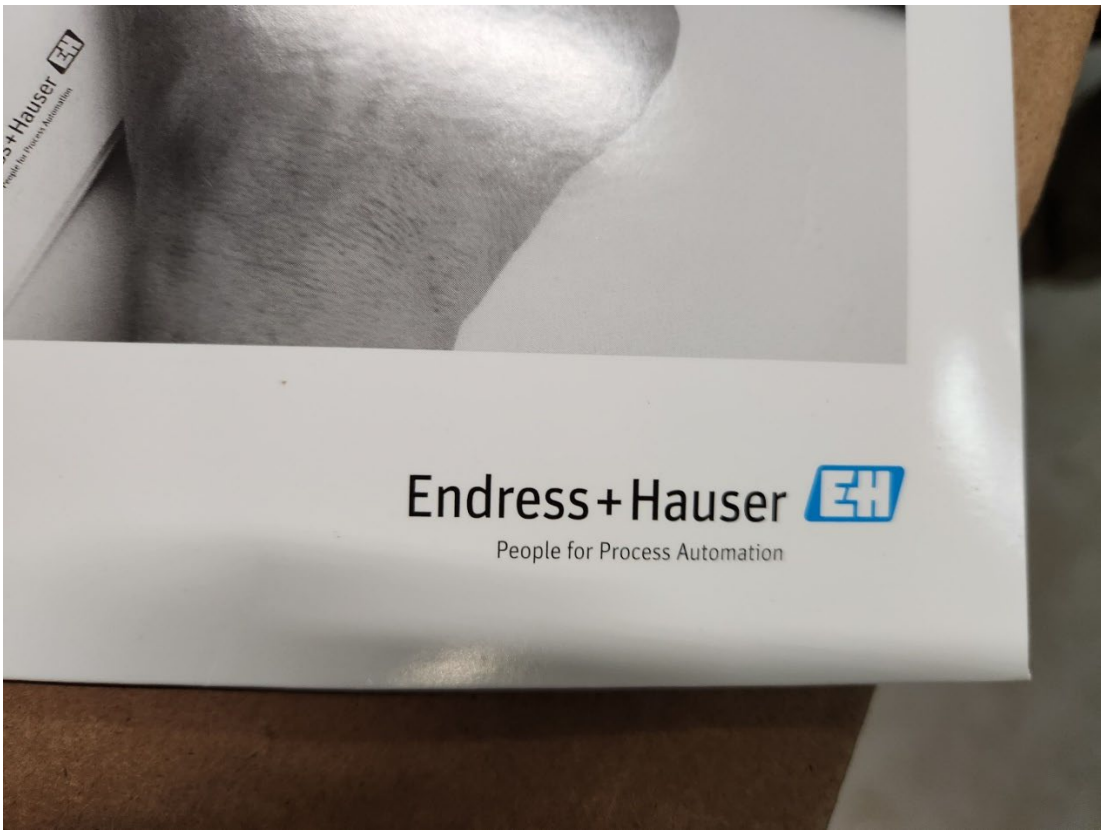
5.5	For flow metering, describe flow meters used, and what they measure.			
Comments: The facility uses Endress Hauser (Promag W model) electromagnetic flow meters to measure recycled water and SIW discharges to the management units (Photograph 6, 7 and 20).

Photo 6: New Endress Hauser (Promag W model) electromagnetic flow meter ready for replacement.
